**Subject:** Node 9 Passband Diagnostics, Removal of Notch Feature, and Feed Cabling Instructions

## I. Executive Summary

Between 10-14 June 2019, we conducted a HERA site visit, the primary purpose of which was to diagnose passbands in node 9 which were deemed to be faulty. This document describes our method of diagnosing faulty passbands, and the individual improvements made by all major steps in the diagnostic process. After diagnosis, the 50-60MHz notch feature was no longer present in the autocorrelation spectra of any polarization of any node 9 feed; the same improvements are now being made to all feeds connected to node 0. Our node 9 diagnosis produced a useful test of node control module (NCM) integrity, which is also described.

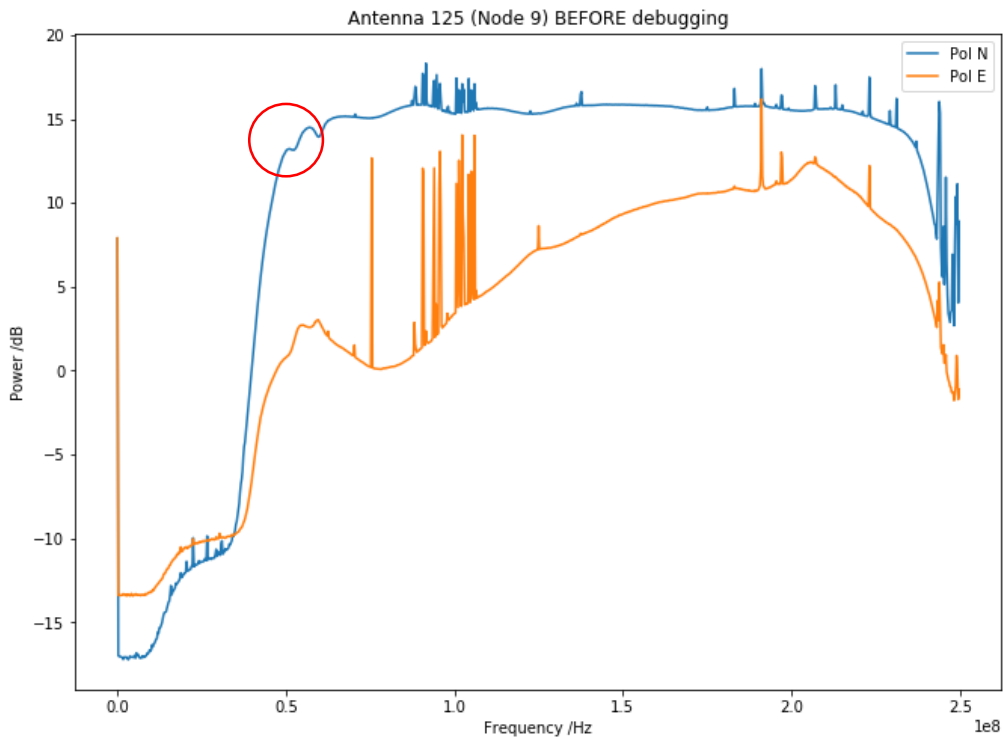
There were multiple ways by which autocorrelation passbands could be deemed problematic. Three primary ways include the presence of the ‘notch’ feature between 50-60 MHz, having a passband which is considerably low in amplitude across the 50-250MHz band, and having ‘ripples’ anywhere in the autocorrelation spectrum which make the passband considerably less flat. Figure 2 demonstrates a combination of problematic features in the N and E polarizations of Antenna 125, prior to debugging.

Figure 2. The autocorrelations of the N/S and E/W polarizations of Antenna 125 recorded by the third SNAP of node 9 before any debugging; both passbands were deemed to be problematic. The N pol, while having a fairly flat passband, contains the 50-60 MHz notch feature (red circle, caused by an inductor-like current loop passing through the springs which fastened the Vivaldi feed to its support ropes). The E pol has a curved, low-amplitude passband. This figure represents the state of the antenna when we started our site trip.

Three refinements to the feed and its connections to the node were made to improve faulty passbands. First, all springs were removed between the Vivaldi feed and its support ropes. Results from a previous site trip and subsequent beam simulations, and data analysis in the HERA Commissioning channel on Slack suggested that spring removal would completely remove, or significantly reduce, the 50-60 MHz notch effect. Second, the SMA, CAT7 and fibre cables extending from the Vivaldi feed to the hub of each dish were systematically checked for damage, wound with plastic ribbon so that the shields of the SMA and CAT7 cables made continuous electric contact, and taped in regions where the cables were at risk of making electrical contact with the fins of the Vivaldi feed. A detailed overview of this cabling process may be found in Appendix A. Third,

both the FEM and PAM side of each single-polarization optical fibre were cleaned (four places to clean – two ends of two fibres).

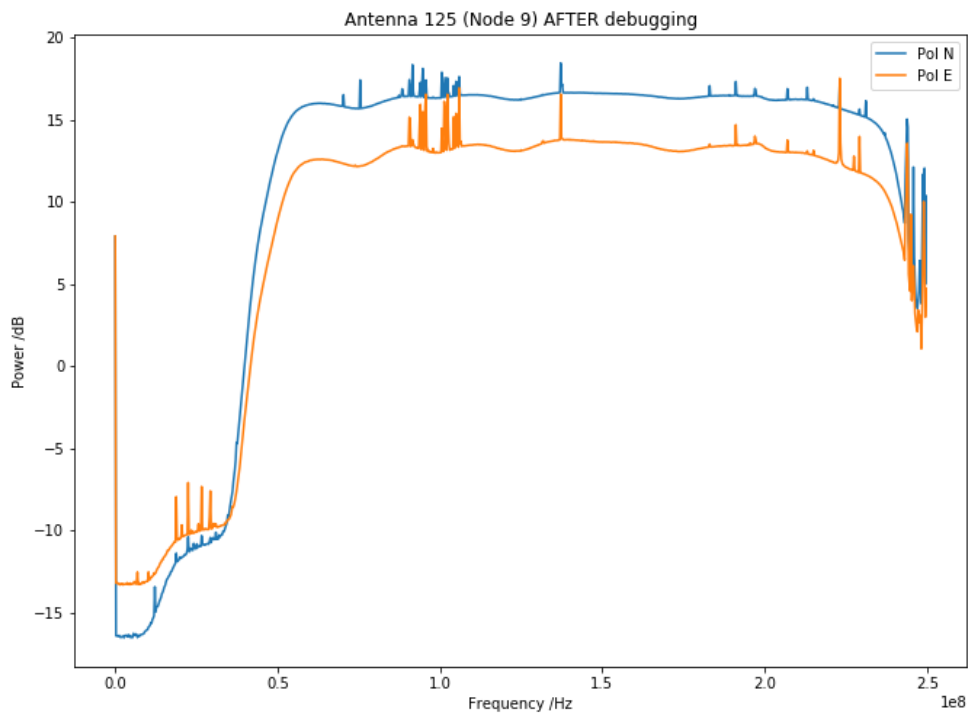
Figure 3. The autocorrelations of the N/S and E/W polarizations of Antenna 125 recorded by the third SNAP of node 9 after all debugging. Differences in passband between this figure and Figure 2 result from springs being removed, cables being installed per Appendix A, the feed being re-lifted and brought down once more, the FEM-PAM fibre connections cleaned, and the feed being re-lifted again.

Figure 3 documents the passband change of the N/S polarization of Antenna 125 after our diagnostic. The passband of Figure 2 was recorded before we made any of the three improvements described above. Figure 3 depicts the passband after the feed was lowered, springs were removed, cables were installed per Appendix A, the feed re-lifted and brought down once more, all four fibre connections described above being cleaned, and then having the feed re-lifted again. Data recorded after the second refinement (springs removed, etc.) and before the third refinement (cleaned fibres) has been lost. Feed repositioning error may have occurred between each of the two datasets, as repositioning was performed using a laser range finder to identify the vertical ('Z') height of the feed above the hub; X/Y error in the feed centre with respect to the hub was minimized by eye. Should the feed not be in the same (X, Y, Z) position with respect to the central hub, it is possible that the impedance of the feed output could change, causing noticeable differences in passband structure between Figures 2 and 3. A future memo will thoroughly document the effects of positioning errors on the antenna beam shape, and describe a method to reliably reposition feeds and minimize their position change due to environmental effects (such as wind, rain, and temperature changes) throughout the course of an observation.

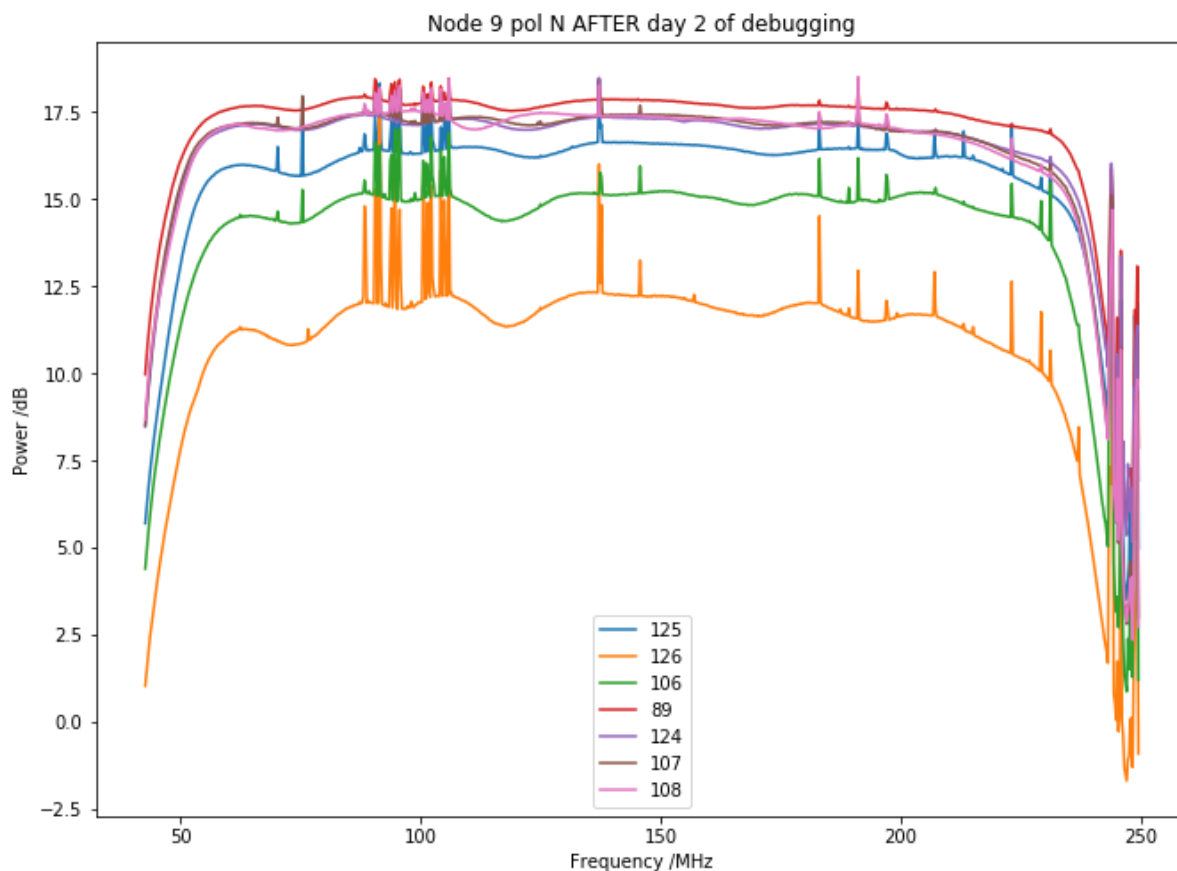
Figure 4. The autocorrelations of the N/S polarization of all antennae of node 9, after all debugging. No polarizations exhibit the notch feature and all have passbands with an acceptably high amplitude.

Figures 4 and 5 represent the last recorded state of all polarizations of all node 9 antennae after passband diagnosis. The passbands of the E/W polarizations of antennae 106 are 124 look considerably different than the rest, and at a much lower amplitude, suggesting they either have a faulty FEM or PAM analogue chain. Note the notch feature in the N/S polarization of Antenna 125, which appears in Figure 2, is no longer present – validating our motivation for removing the springs from all feeds. The notch feature does not show up in any polarization of any antenna after debugging.

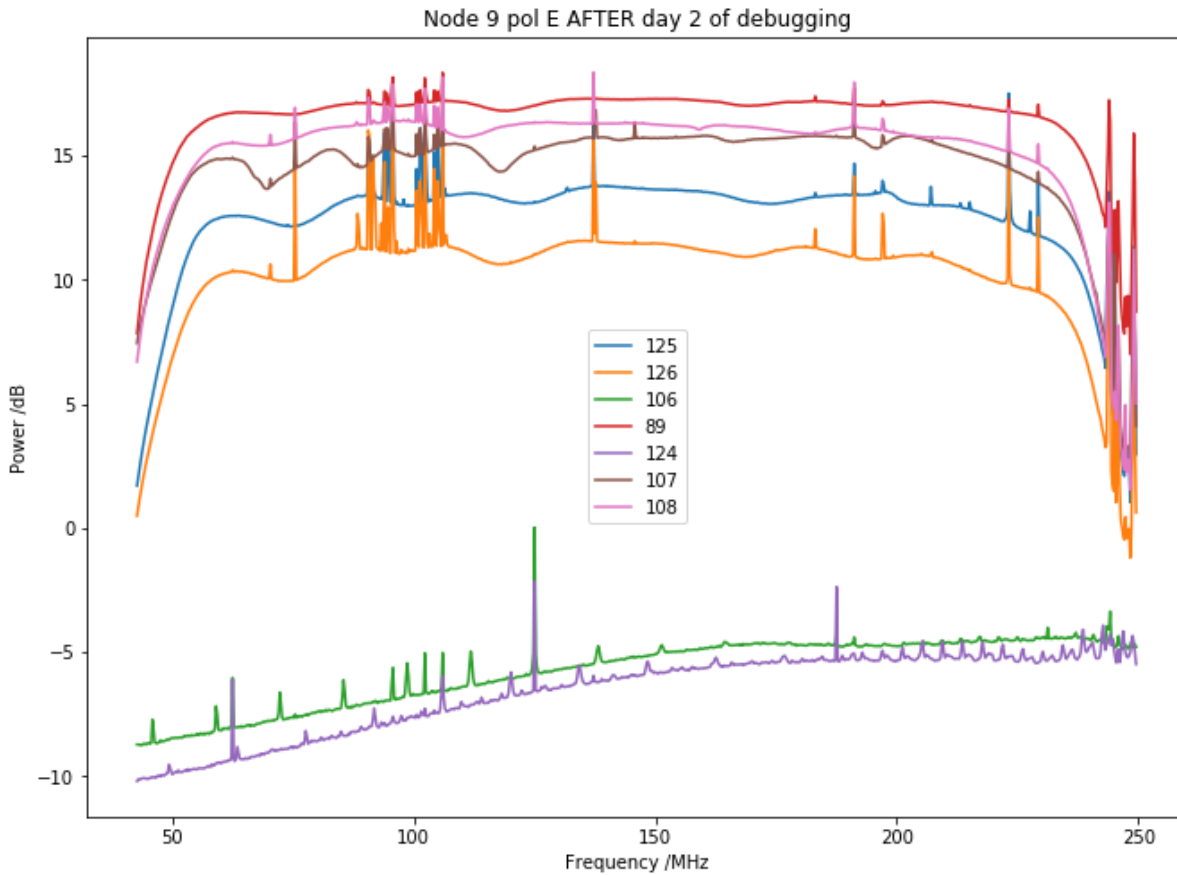
Figure 5. The autocorrelations of the E/W polarization of all antennae of node 9, after all debugging. No polarizations exhibit the notch feature. All polarizations have passbands with an acceptably high amplitude, except for antenna 106 and 124, which likely have a faulty FEM or PAM.
